Cost-Effective Snow Fence Usage—D.I.M.E.

ABSTRACT

Key words: snow fences, snow drifting, highway.

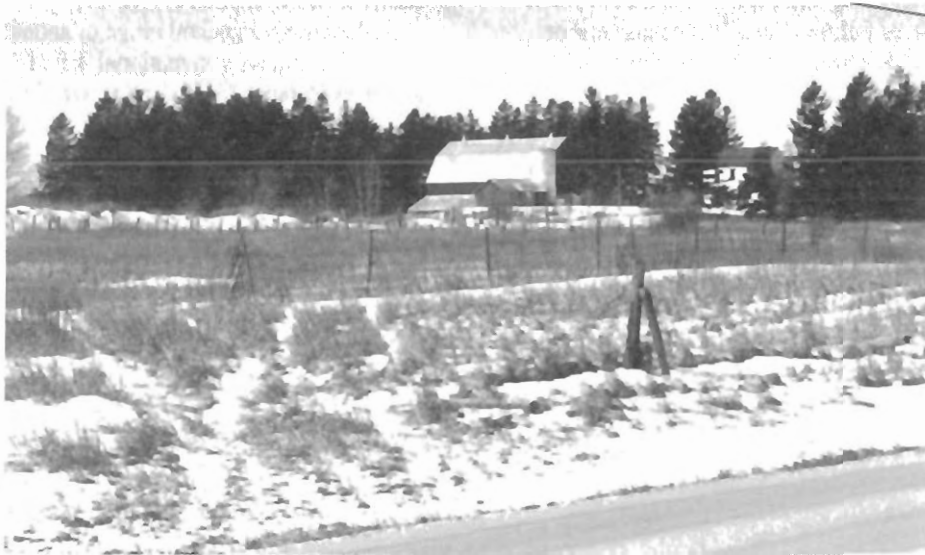
Figure 1. The fence in this example is not collecting snow because of a small upwind fetch and ground cover that will contain most driftable snow. There is not likely a severe problem at this site. The discontinuation of the use of this fence will not affect snow accumulation on the road and save in the order of \$500 annually.

Discontinuing the use of snow fencing is sometimes considered at a site with a recurring problem where temporary fences are perceived as not being worthwhile because "they don't work". As illustrated in Figures 1 and 2 their failure is usually because one or more of the **D.I.M.E.** parameters were not followed.

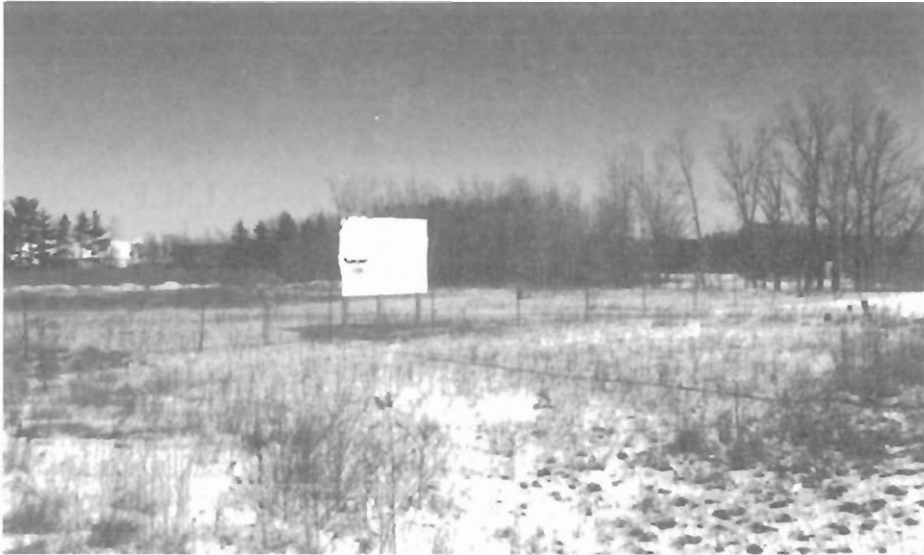
Figure 2. In this case the fence material used is intended for crowd-control and is not dense enough for snow fencing. The problem should be evaluated and if the severity warrants, install a fence with higher density. In this case \$500 was wasted because an ineffective fence was installed. Opaque material (center) was used in this photo on billboard.

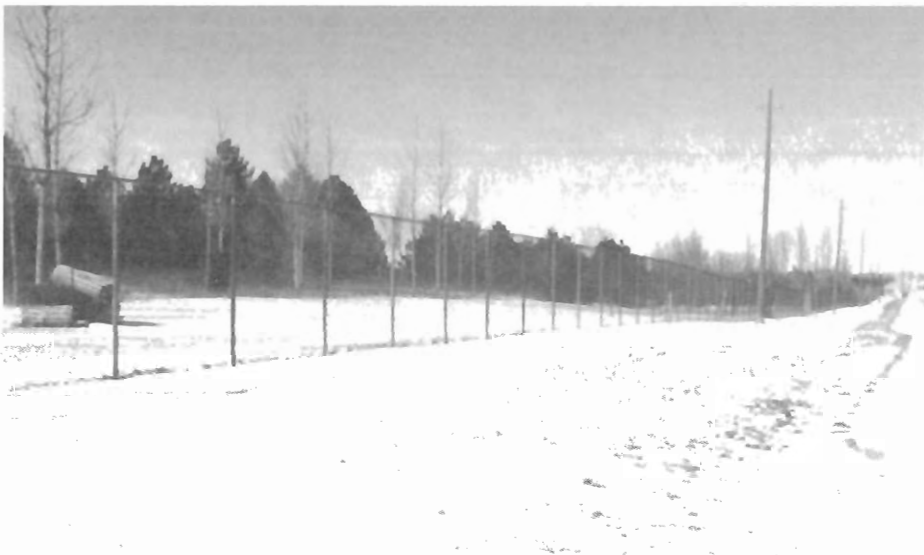
Figure 3. The discontinuation of the use of snow fencing at this site in favour of a permanent row of trees eliminates the annual installation of fencing. Annual savings for 300m of the road shown could be \$1,500.

However, as demonstrated in Figure 3, if thought is given to a problem and a workable solution, savings can be achieved which still provide the expected level

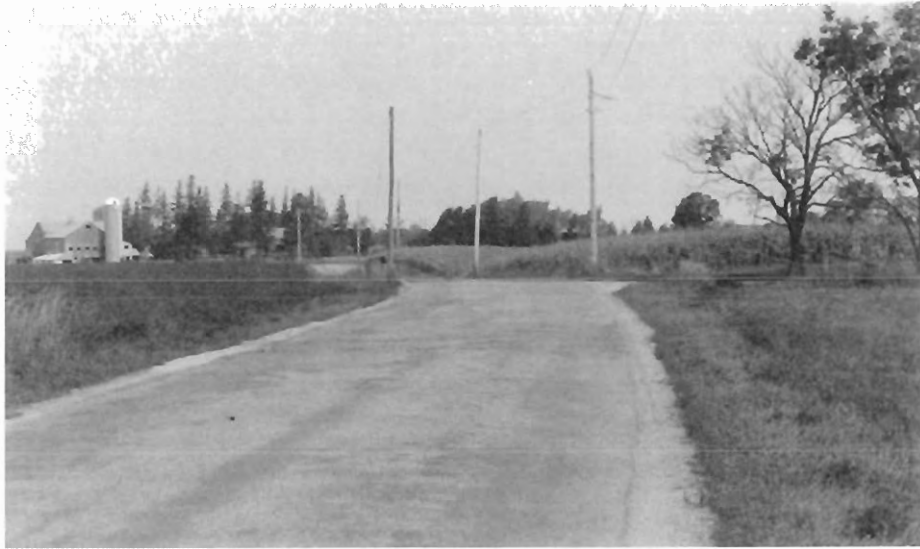
Figure 6. Woolwich Street Site - Waterloo

In 1985, the City of Waterloo had a study conducted to assist them in controlling snow drifting on Woolwich Street which services a satellite subdivision. As shown in Figure 6, this road is narrow and is constructed with no ditches.

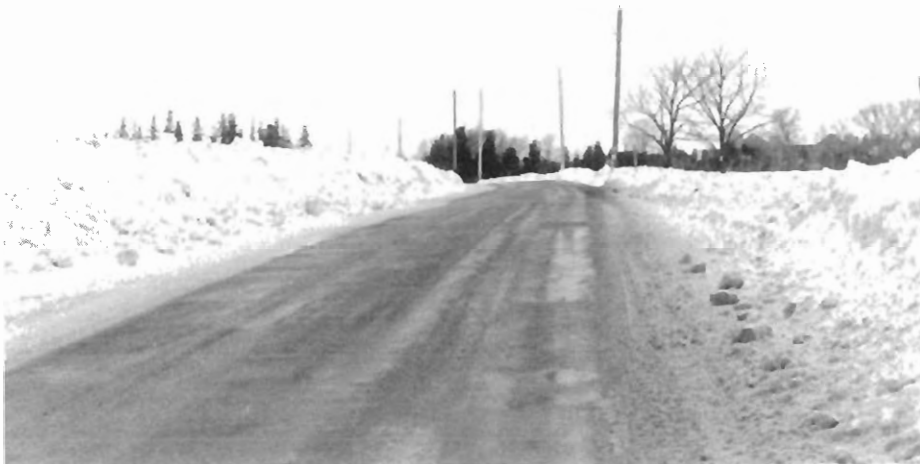
Figure 7. Snow Accumulation Along Woolwich Street Without Snow Fences

This method of construction does not allow for the storage of plowed snow as illustrated in Figure 7. Typically, when a road with an outdated design exists it is usually upgraded with an elevated cross section which also has large ditches to store plowed snow similar to the section in Figure 8. However, the deeds for the neighbouring properties indicated that, in some areas, a public right-of-way did not exist, and their property lines aligned with the centre of the road. Therefore, the most straight forward approach to a solution was to use temporary snow fencing in the neighbouring fields after the crops were harvested each fall.

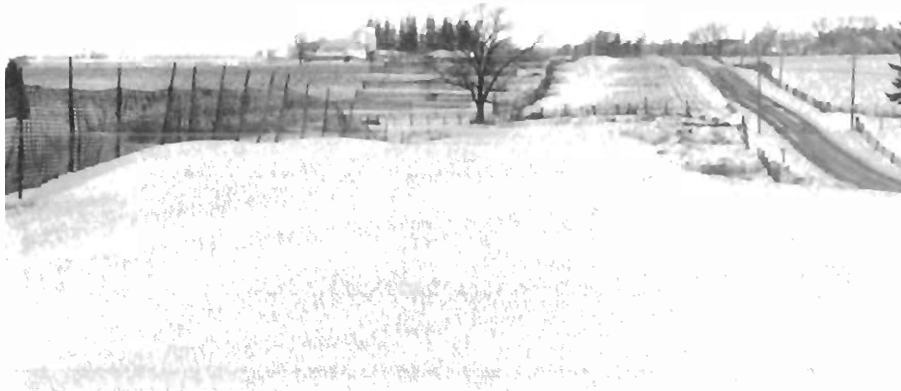
Figure 10. Recommended Solution - 2 Rows of snow fence

The initial method of calculation did not allow for the freeze/thaw cycles that occur in this region of Ontario. As a result a conservative design was achieved which allowed an over estimated amount of snow that drifts towards the road. Since the installation of the snow fences at this site, new work (Baker and Williams 1990) and the monitoring done by the City of Waterloo indicate that 2 rows of conventional snow fences were adequate to collect the volume of driftable snow (Figure 10).

This process produced a reliable solution and reduced the cost of installation/removal by 1/3. It is estimated that this results in a reduction of 1000 m of fence to be erected and removed annually. Using the current average rate (\$4.96 per m) this reduction in the amount if snow fence installed translates into a \$5,000 savings each year.

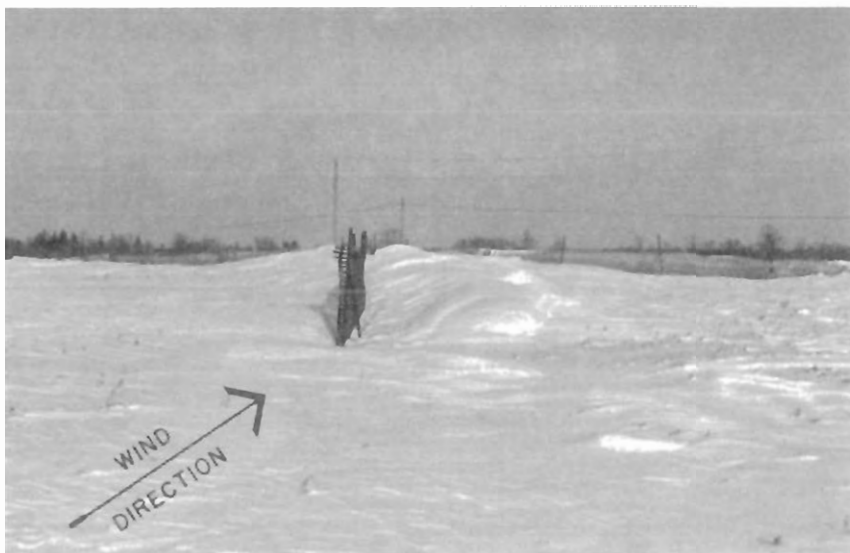
Figure 12. Snow Accumulations at Misaligned Fence

A choice of solutions was given which included adding snow fences or regrading the upwind cut. During the first winter after the study snow fences were installed as the chosen solution. Part way through the winter the site was viewed when it was reported that the fence was not working efficiently. As can be seen in Figure 12, the fence that was installed was parallel to

the prevailing winds instead of perpendicular to the wind as recommended. As a result of this misalignment, minimal snow accumulated at the fence thus allowing more snow to drift towards the highway than with the recommended alignment. During subsequent winters a correctly aligned fence was found to work more effectively.
