## **Aeration Systems and Winter Streamflow Measurements at Sleepers River, Danville, Vermont**

J.C. DENNER AND J.B. SHANLEY  
U.S. Geological Survey  
P.O. Box 628  
Montpelier, Vermont 05601, U.S.A.

Research on water, energy and biogeochemical budgets was recently initiated at Sleepers River Research Watershed in rural northeastern Vermont. During the winter of 1990-91, aeration systems, designed to limit the accumulation of ice at streamflow-gaging station controls, were installed in two basins. At gaging-station W-5, which records flow from a 43-square-mile basin, aeration at the broadcrested concrete weir control was not totally effective at eliminating ice. Supplementary manual ice removal was necessary during extremely cold periods. At gaging-station W-3, which records flow from a 3.2-square-mile basin, the aeration system kept the concrete V-notch weir ice-free at temperatures above -18 degrees Celsius. To verify that the controls were free of backwater from ice, winter current-meter discharge measurements were made at open-water cross-sections at both sites. These measurements fell within 5-percent of the established rating curve, thus validating the open-water stage-dis

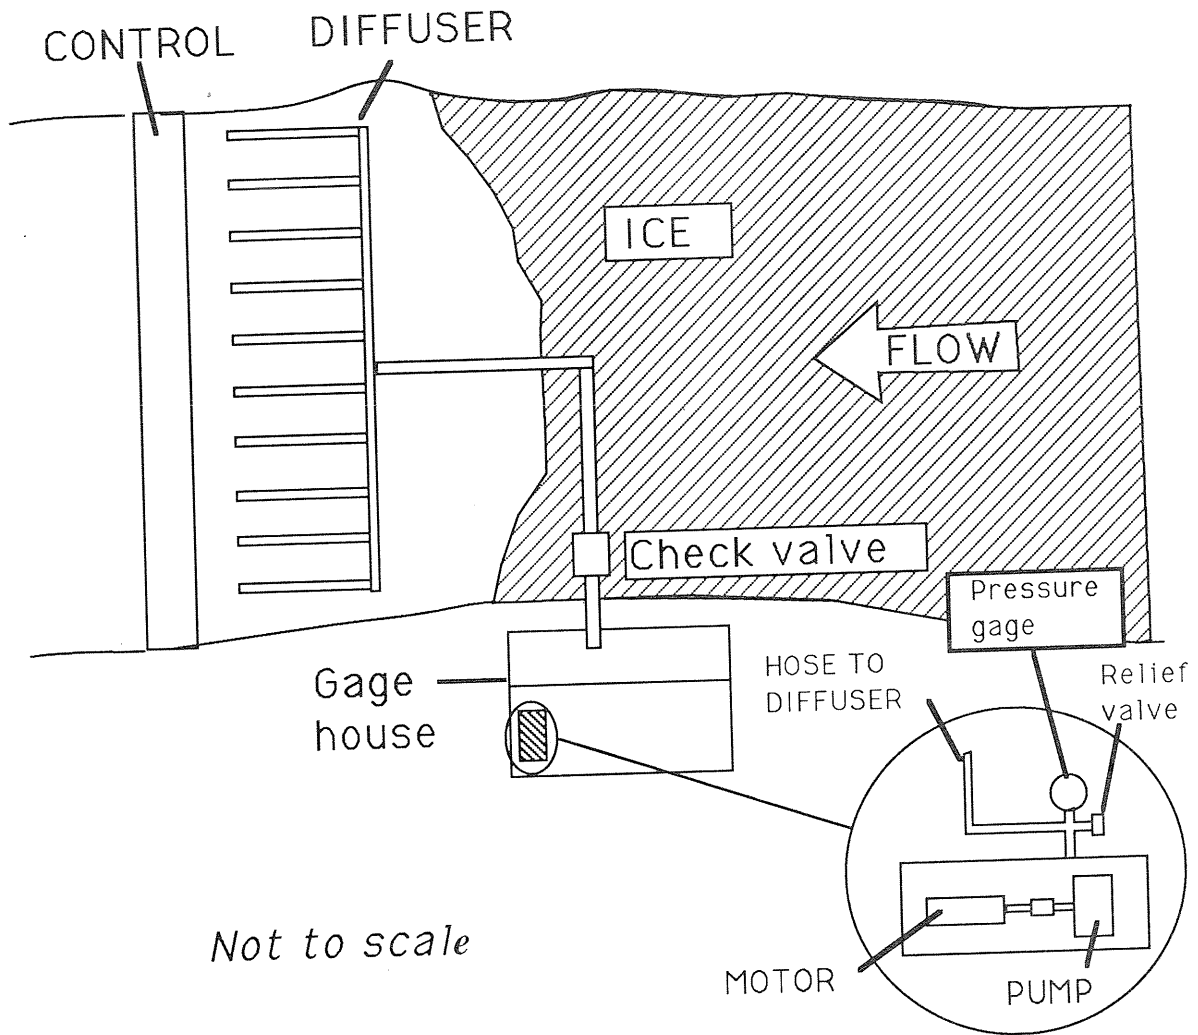
Figure 2. Schematic of aeration system used at station W-5 (diffuser configuration as in installation #1) and station W-3, plan view.

*Site W-5* -- The aeration system at station W-5 (Figure 2) consisted of an air pump mounted in the gage house. A pressure gage and pressure relief valve were attached under the pump. The air line, consisting of black plastic water pipe, was bracketed to the inside of the stilling-well wall and it exited from the intake pipe. A brass check valve was installed in the air line just past the end of the intake. In installation #1 (Figure 2), the air line ran downstream about 20 ft (6 m) to a connection in the middle of the manifold. The 50-ft (15-m)-long manifold was positioned 10 ft (3 m) upstream from and parallel to the weir. The manifold was held in place by a steel cable attached to ledge rock at each bank. Eleven 10-ft (3.0-m)-long diffuser-fingers, extending downstream and perpendicular to the manifold, were spaced at 5.0-ft (1.5-m) intervals. Five 3/64-in, (1.2-mm)-diameter holes were drilled in each diffuser spaced at 2-ft (0.6-m) intervals. The operating pressure of the system with 55 holes was 2 to 3 lb-in<sup>-2</sup> (14 to 21 KPa). The pump capacity limited the number of holes at 50 to 60; beyond this number the pump was unable to maintain adequate air pressure required for effective bubbling.

*Station W-3* -- The aeration system at station W-3 (Figure 2) was similar to the original system (installation #1) at station W-5. The pump assembly was mounted in the gage house and the air line descended into the stilling well and out the intake. The air line connected to the manifold 10 ft (3 m) downstream from the gage. Six 10-ft (3-m)-long diffusers attached to the 10-ft (3-m)-long manifold at 2-ft (0.6-m) spacings. Each diffuser had nine 3/64-in (1.2-mm)-diameter holes at 1-ft (0.3-m) spacings. The manifold line was stabilized by attaching it to metal fence posts. As at station W-5, the assembly was held in place by rock weights. The heated air from the pump together with adequate earth banking kept the stilling well ice-free without an auxiliary heater.

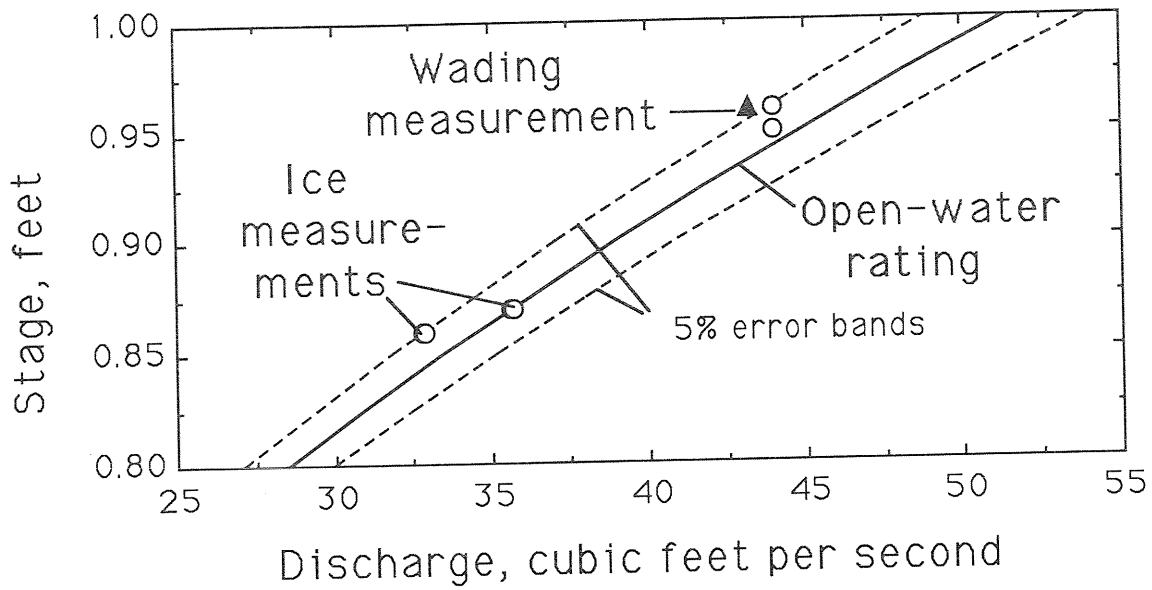
Figure 3. Stage-discharge rating at station W-5, with 5-percent error bands, 6 winter ice measurements, and one wading measurement.

The discharge determined from the single winter open-water measurement at station W-5 was 4.5 percent less than the rated discharge (Figure 3). Because this value is within the normally accepted 5-percent error for streamflow measurements, the winter open-water measurement was considered to fall on the rating. Although only one open-water measurement was made at station W-5, six winter open-water measurements validated the established stage-discharge rating at station W-3. The six measurements each fell within the acceptable 5-percent error range (Figure 4).

All six discharge measurements under ice at station W-5 plot within 5 percent of the open-water rating; values range from -4.9 to -1.1 percent (Figure 3). The apparent negative bias in the results may reflect minimal backwater caused by ice effect. Also, the current meter used for this study may underregister velocities in depths less than 1.5 ft (0.46 m) because of interference caused by the boundary effect (Rantz, 1982). The results show that discharge measurements made under ice cover at station W-5 during favorable conditions meet the 5-percent accuracy criterion.

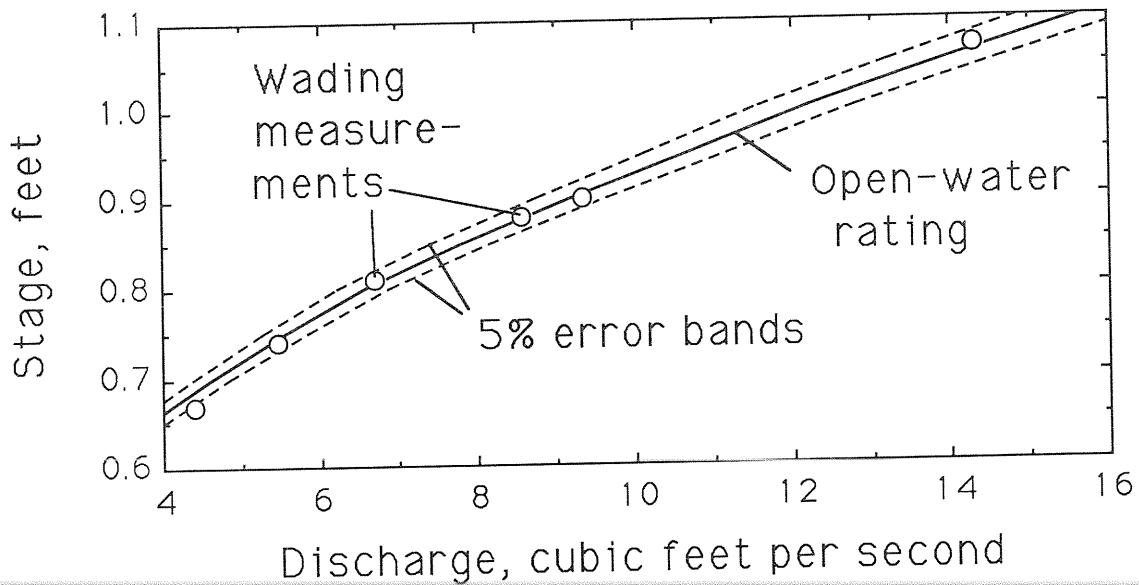
Figure 4. Stage-discharge rating at station W-3, with 5-percent error bands and 6 wading measurements.
