## Arctic Snowfences—A Big Solution For a Big Problem

### ABSTRACT

This paper presents a history of arctic community snowfencing projects in North America and the successes and some of the problems encountered. Construction methods and responses from communities employing arctic snowfences are also reviewed.

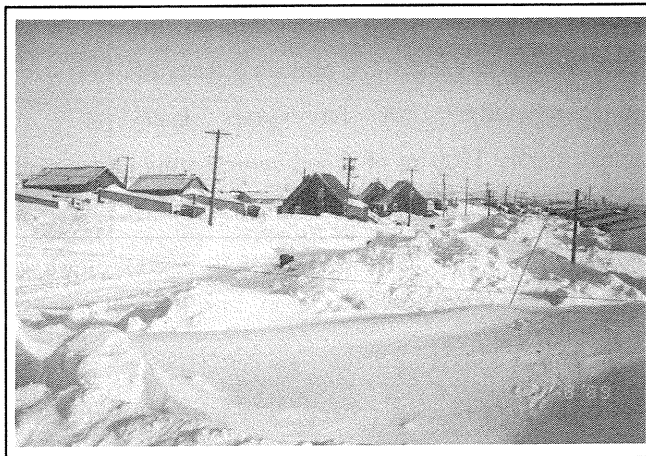
**Figure 1:** Severe snowdrifting conditions often experienced in Arctic communities.

Arctic communities are often inundated with large snowdrifts, some three to five metres deep, that bury homes and obstruct streets (Figure 1). Combating these large snowdrifts requires more than the brute force of snowclearing equipment, which is an expensive short-term solution. The first permanent arctic snowfence (i.e. four to six metres tall) used to reduce snowdrifting in communities in arctic regions of North America was installed at Wainwright, Alaska in 1982 by the North Slope Borough Government. Since that time, tall snowfences have been installed to reduce
